**Flood Control Project Maintenance
Levee Inspections**
LMA District Cover Sheet
Spring 2019 Levee Inspection Results

Reclamation District No. 0536 Egbert

Spring 2019 Levee Inspection Results

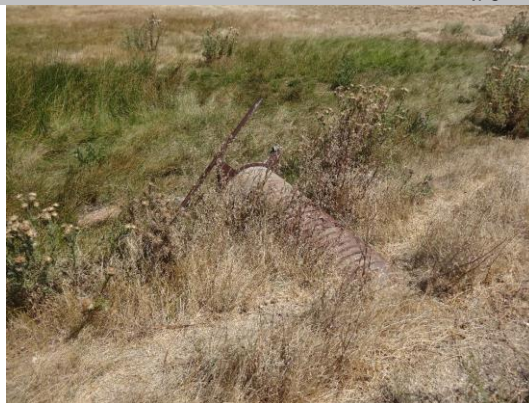
Photo 1 of 3 : UCIP_SP_2019_49313_34774.jpg

WS view: overview of exposed CM pipe on levee slope.

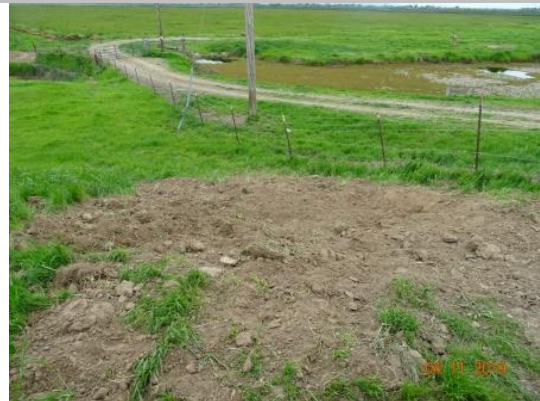
Photo 1 of 1 : SP_2019_RD0536_208_30_20190412_00054.jpg

View looking downslope of exposed slope instability on the waterside slope (Spring 2019).

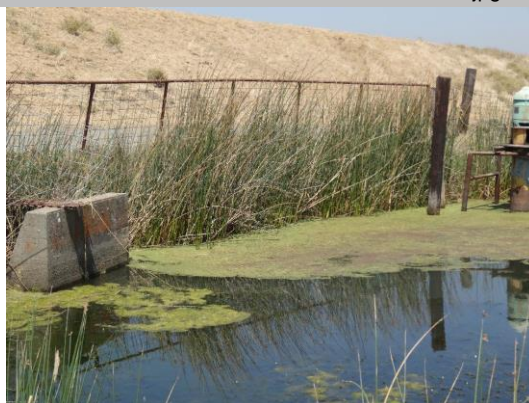
Photo 2 of 2 : UCIP_SP_2019_20444_34492.jpg

LS view: concrete headwall in the channel/irrigation ditch. Pipe submerged into water.

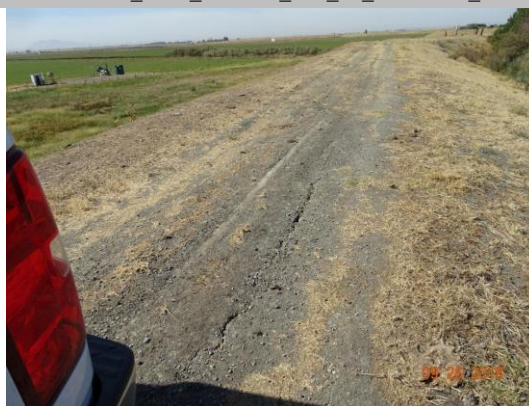
Photo 1 of 1 : SP_2019_RD0536_208_22_20190311_00012.jpg

View looking upstream at the crown. Surface cracks should be fixed and gravel added to roadway (September 2018).

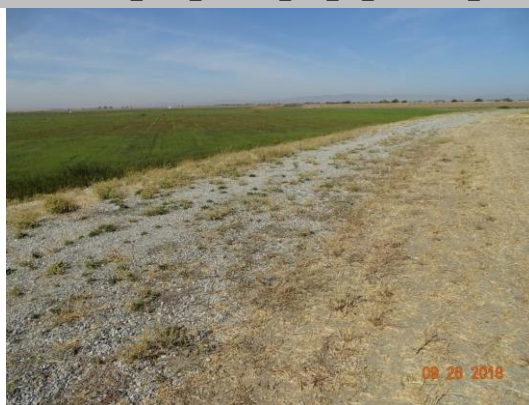
Photo 1 of 2 : SP_2019_RD0536_208_56_20190311_00020.jpg

LM Start	2.69	Rating **	A/W	Issue No.	56
LM End	2.71	Issue Type +	Ma	Location *	CR
Category	Earthen Levee			GPS Latitude/Longitude	
				Start	End
Item	Crown Surface / Depressions / Rutting			38.255197 °	38.254973 °
				-121.737932 °	-121.737577 °
DWR ID	DWR_RD0536_01_f_2014_56				
Comment Code					
C2 : Repair depressions or ruts in the crown or slope.					
Inspector Comment					
Possible subsidence in this area has been repaired. Grade was restored and base rock was added to crown. Area looks good on 3/29/18. Should continue to monitor this site for possible future subsidence.					
9/26/2018: Very minor subsidence present. Should be monitored.

View looking upstream at minor subsidence. (September 2018).

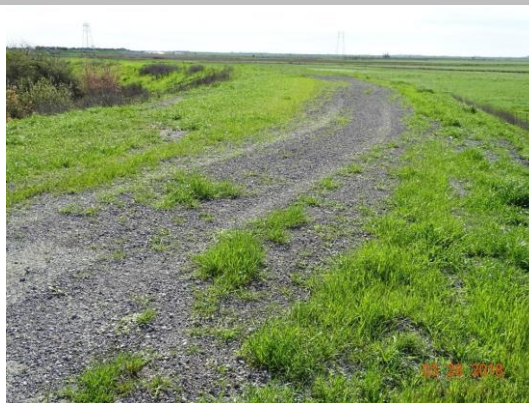
Photo 2 of 2 : SP_2019_RD0536_208_56_20190311_00021.jpg

3/29/2018: view of crown rutting and possible subsidence that has been repaired.

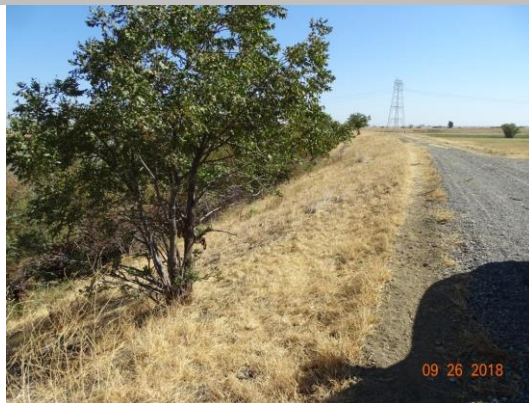
Photo 1 of 1 : SP_2019_RD0536_208_24_20190311_00014.jpg

View looking downstream at walnut trees on the water side crown (September 2018).

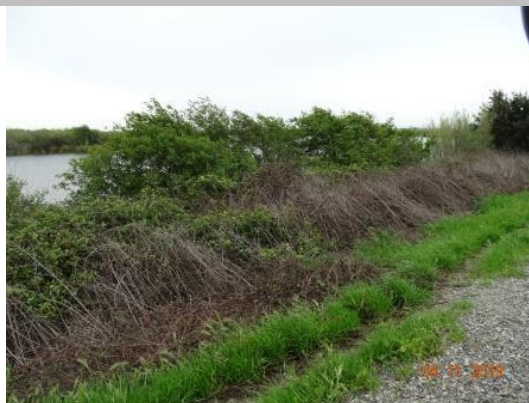
Photo 1 of 1 : SP_2019_RD0536_208_34_20190412_00058.jpg

View looking downstream at blackberries on the waterside slope (Spring 2019).

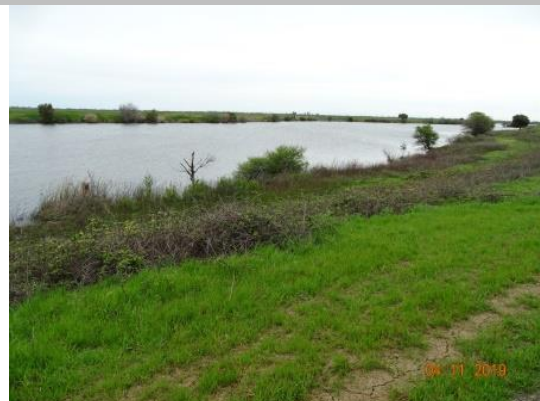
Photo 1 of 1 : SP_2019_RD0536_208_41_20190412_00060.jpg

View looking downstream at blackberries on the waterside slope (Spring 2019).

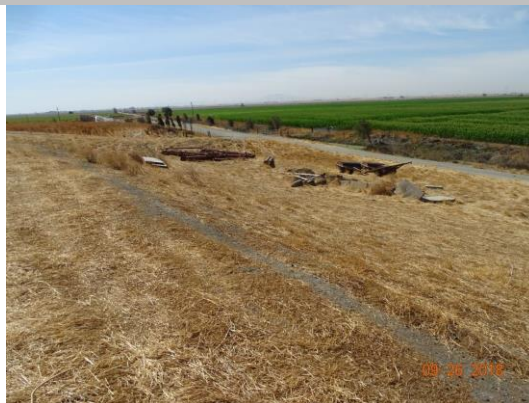
Photo 1 of 1 : SP_2019_RD0536_208_23_20190311_00013.jpg

View looking down slope of farm equipment on the landside slope (September 2018).

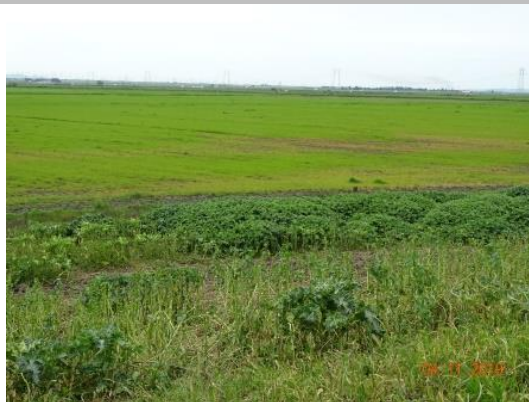
Photo 1 of 1 : SP_2019_RD0536_208_43_20190412_00062.jpg

View looking downslope at vegetation at the bottom of the landside (Spring 2019).

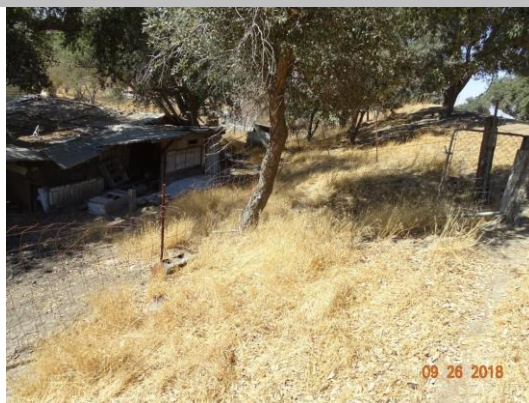
Photo 1 of 2 : SP_2019_RD0536_208_25_20190311_00015.jpg

View of fence on the landside slope (September 2018).

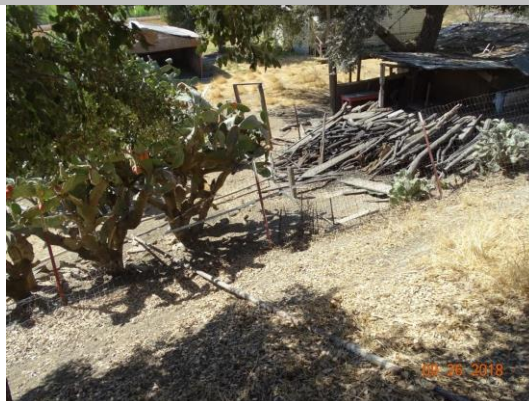
Photo 2 of 2 : SP_2019_RD0536_208_25_20190311_00016.jpg

Cactus, fence, and wood piles at the landside toe (September 2018).

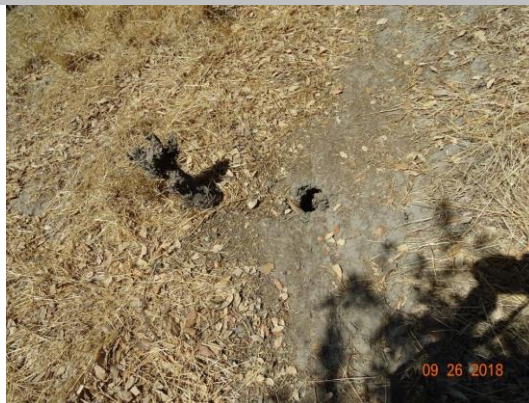
Photo 1 of 1 : SP_2019_RD0536_208_26_20190311_00017.jpg

View of squirrel hole on the landside slope (September 2018).

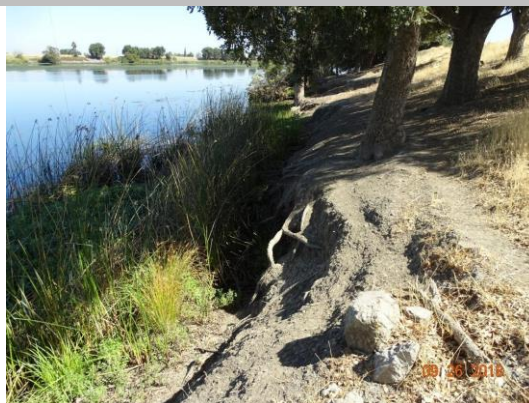
Photo 1 of 1 : SP_2019_RD0536_208_16_20190311_00004.jpg

Deeper erosion at the toe with roots exposed (September 2018).

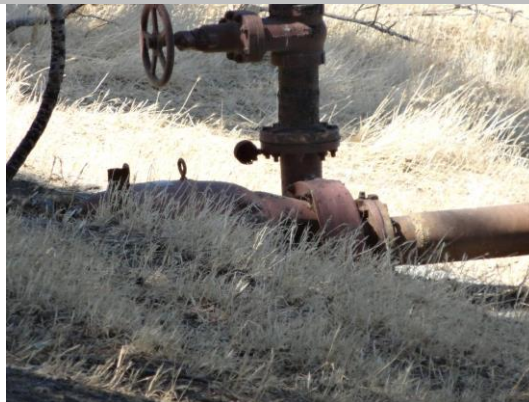
Photo 2 of 2 : UCIP_SP_2019_20543_34622.jpg

WS view: closer view of abandoned pipe, pump, and gate valve on levee slope.

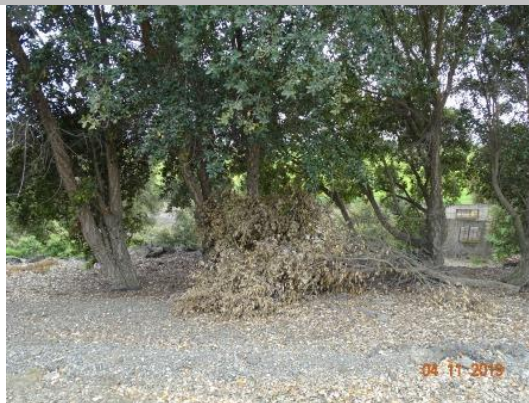
Photo 1 of 1 : SP_2019_RD0536_208_28_20190412_00063.jpg

View of tree limbs on the landside shoulder (Spring 2019).

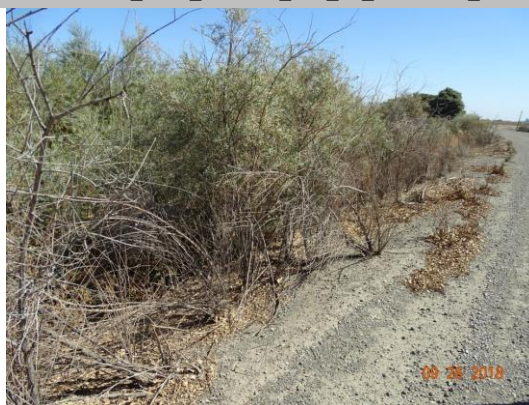
Photo 1 of 1 : SP_2019_RD0536_208_27_20190311_00018.jpg

View of vegetation on the waterside up to the crown that is blocking visibility (September 2018).

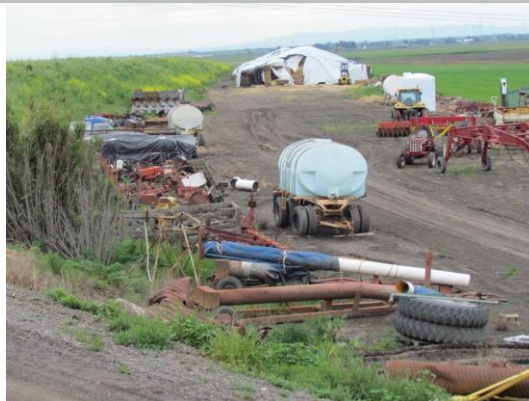
Photo 1 of 1 : SP_2019_RD0536_209_5_20190311_00001.jpg

View of equipment on the landside toe.

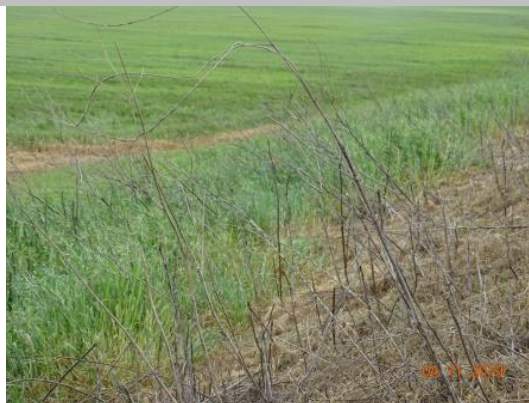
Photo 1 of 1 : SP_2019_RD0536_209_16_20190412_00021.jpg

View looking downstream at annual vegetation on the waterside slope (Spring 2019).

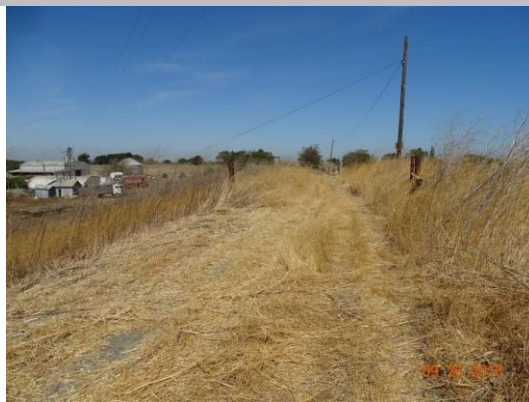
Photo 1 of 1 : SP_2019_RD0536_209_10_20190311_00004.jpg

View looking upstream at vegetation on the crown (September 2018).

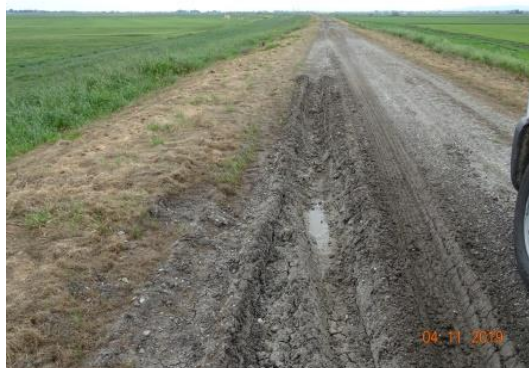
Photo 1 of 1 : SP_2019_RD0536_209_17_20190412_00022.jpg

View looking downstream at deep rut on the crown (Spring 2019).

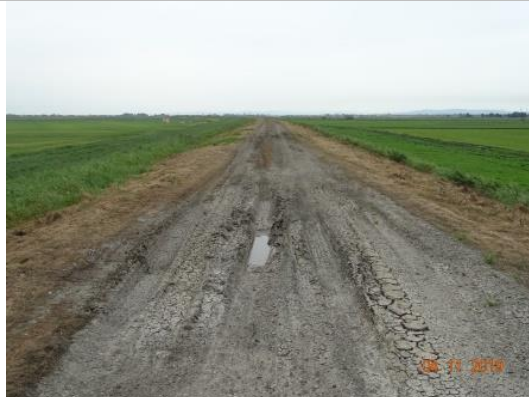
Photo 1 of 1 : SP_2019_RD0536_209_18_20190412_00023.jpg

View looking downstream at deep rut on the crown (Spring 2019).

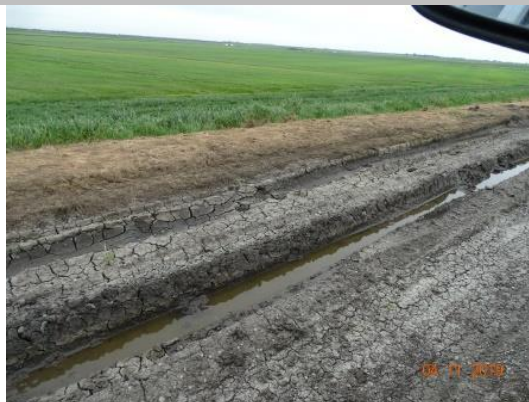
Photo 1 of 1 : SP_2019_RD0536_209_19_20190412_00024.jpg

View looking slightly downstream at deep rut on the crown (Spring 2019).

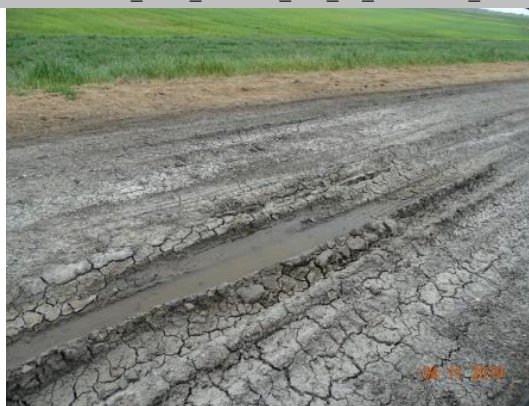
Photo 1 of 1 : SP_2019_RD0536_209_20_20190412_00025.jpg

View looking slightly downstream at deep rut on the crown (Spring 2019).

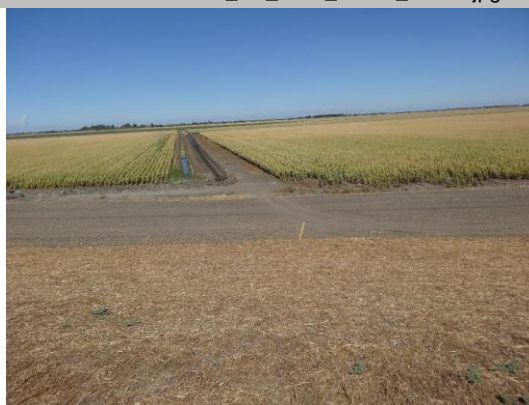
Photo 1 of 3 : UCIP_SP_2019_20664_34746.jpg

WS view: overview of levee slope and gasline indicator. The indicator is different than standard indicators.

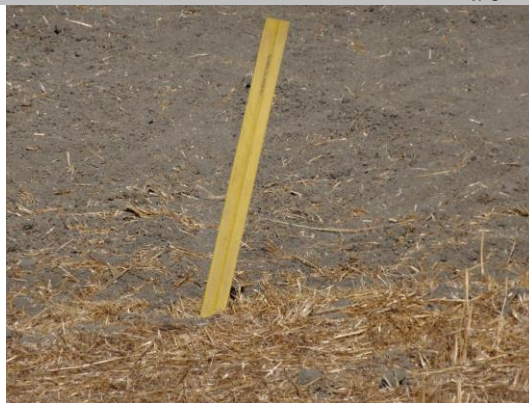
Photo 2 of 3 : UCIP_SP_2019_20664_34745.jpg

WS view: closer look at gasoline indicator. The indicator is different than standard indicators.

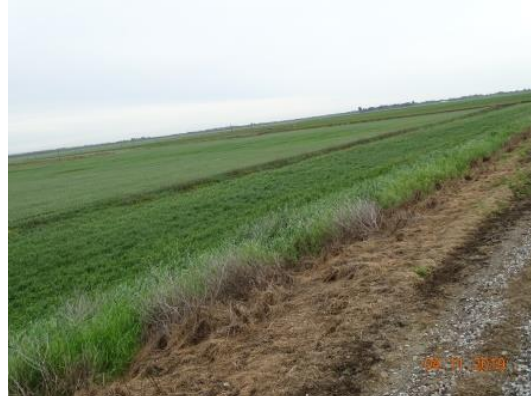
Photo 1 of 1 : SP_2019_RD0536_209_23_20190412_00027.jpg

View looking downstream at annual vegetation on the waterside slope (Spring 2019).

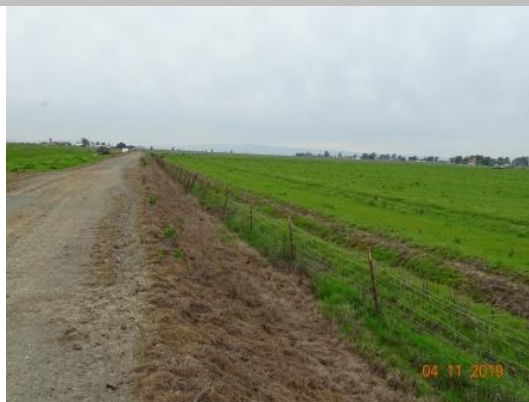
Photo 1 of 1 : SP_2019_RD0536_209_25_20190412_00028.jpg

View looking upstream at barbed wire fence at landside toe (Spring 2019).

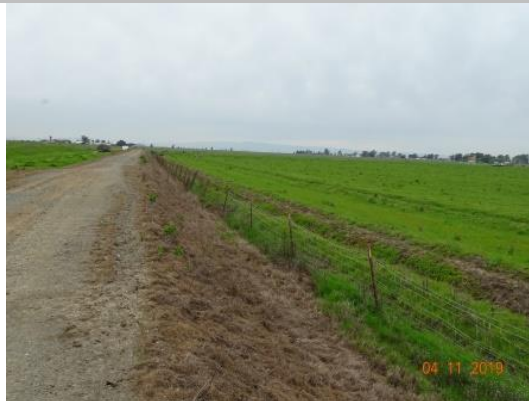
Photo 1 of 1 : SP_2019_RD0536_209_26_20190412_00029.jpg

View looking upstream at ditch on the landside toe (Spring 2019).
